Subj: Report on a coal outburst  
No. 27 mine, Island Creek  
Coal Company, Ragland, Mingo  
County, West Virginia

COAL OUTBURST  
NO. 27 MINE  
ISLAND CREEK COAL COMPANY  
RAGLAND, MINGO COUNTY, WEST VIRGINIA  
DECEMBER 7, 1956

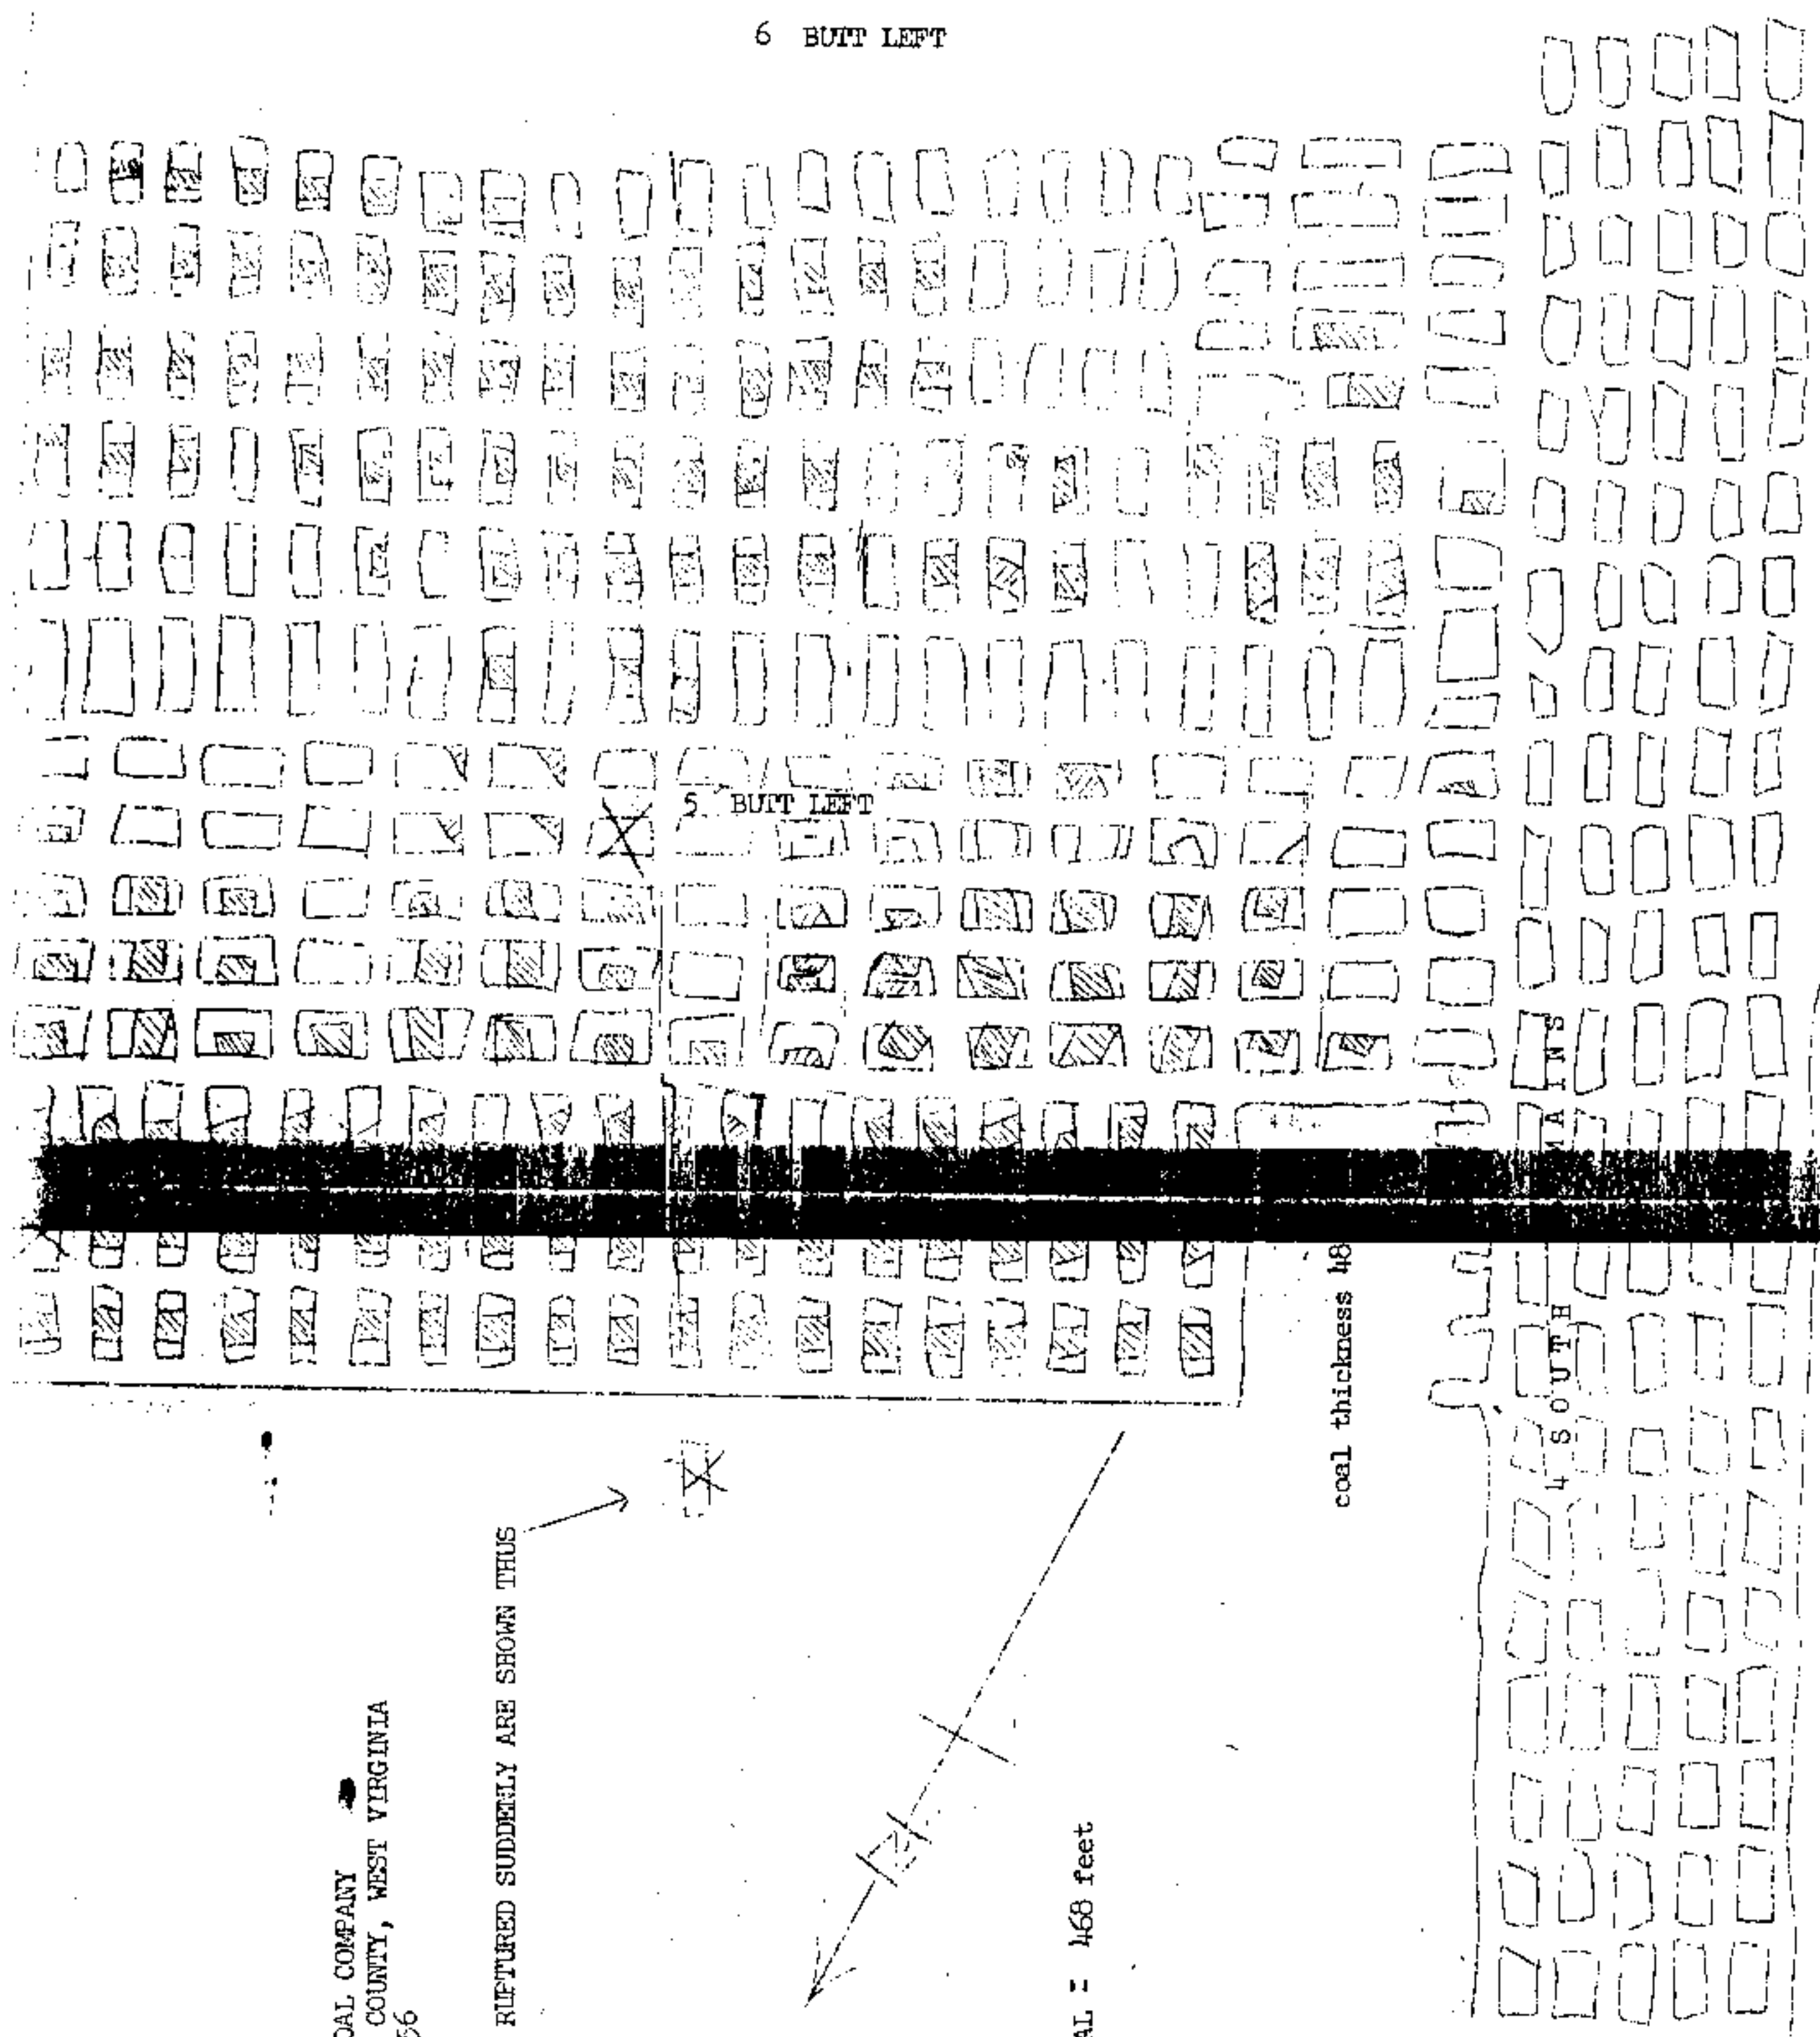
The aforementioned outburst occurred when No. 3 room was approaching the core of an unusually large pillar block that had been left in 6 butt left when the area was originally mined. Outbursts occurred simultaneously in three pillars in the same general area.

6 BUTT LEFT

NOTE: PILLARS RUPTURED SUDDENLY ARE SHOWN THUS

STRATA OVER COAL = 468 feet

coal thickness 48

- (1) The mining system should be projected so that the pillars can be recovered, to the fullest extent possible, by the open-end method in a systematic manner.
- (2) If the present system of partial pillar recovery is continued in the 4 south area, cribs should be installed to supplement the roof-control method being used.
- (3) Consideration should be given to leaving a pillar or pillars of sufficient size intact in the 4 south mains and the mouth of 5 butt left to relieve the stresses on the outby area.
